Safety Inspection Report

Pond Inspection

Badingham Parish Council

23 September 2022

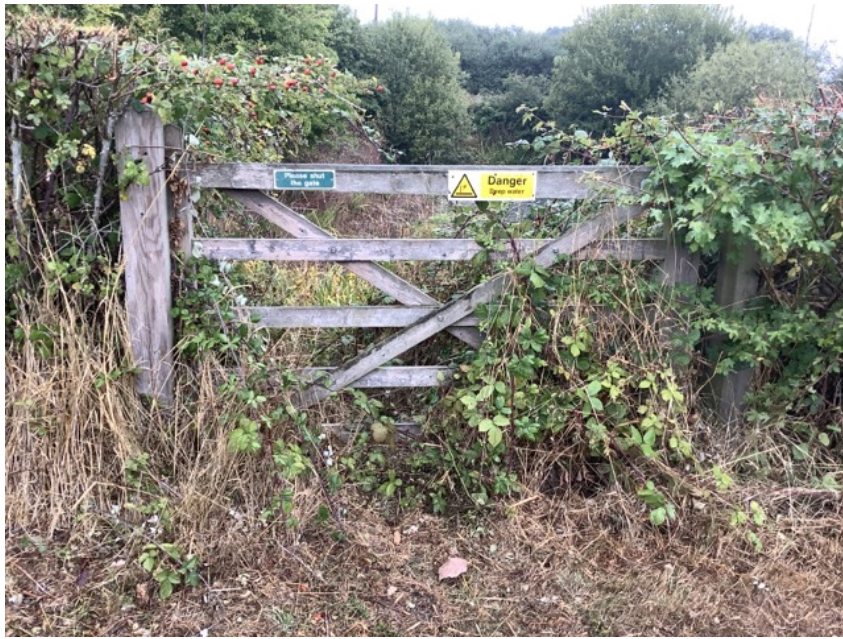
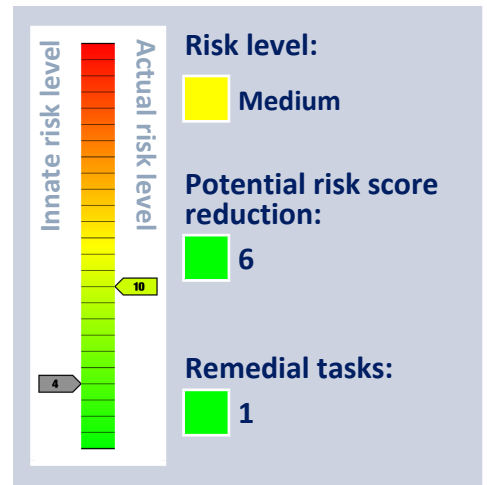
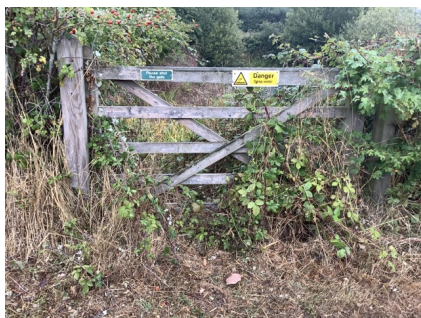
Gate is climbable, and the access is made difficult without being cut / scratched due to the thorn bushes around the latch.

If there was an accident in the pond or pond area emergency access would be impeded.

Risk level:

Medium

Trim back hedge and vegetation around the gate and further into the area.

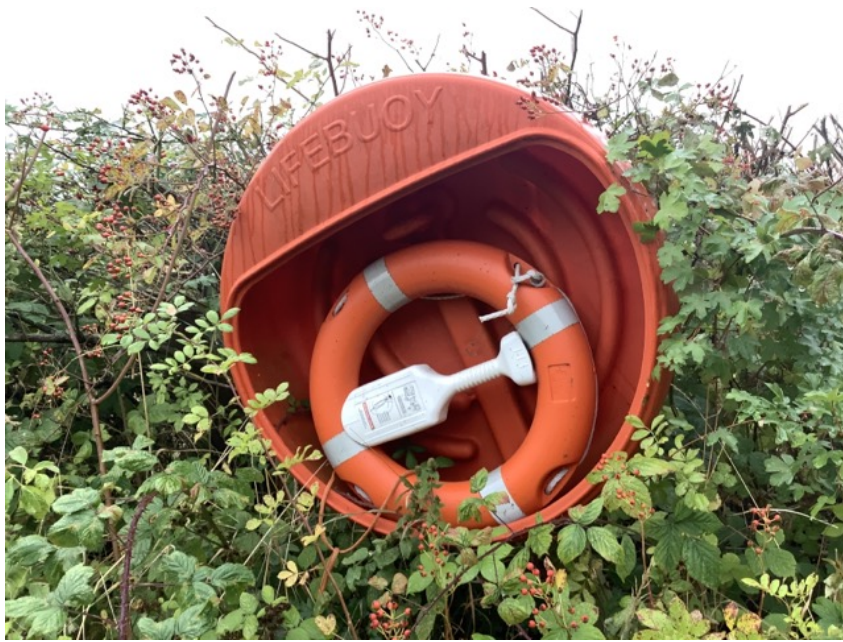
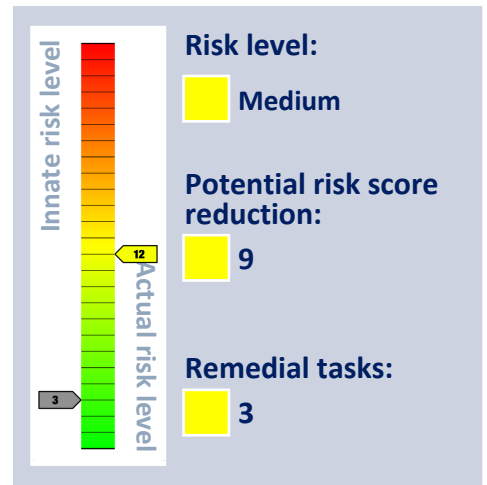
Life Buoy

The supports are loose in the ground.

Post is loose in the ground and leaning, allowing the buoy to fall out of the case.

Re-set.

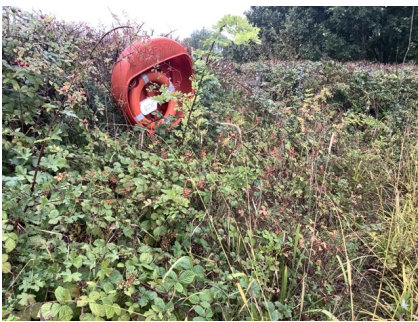
Surface has unintended weeds.

Access to the life buoy is impossible without being injured on the brambles and vegetation.

Medium

Clear all vegetation around this area to make clear and easy access.

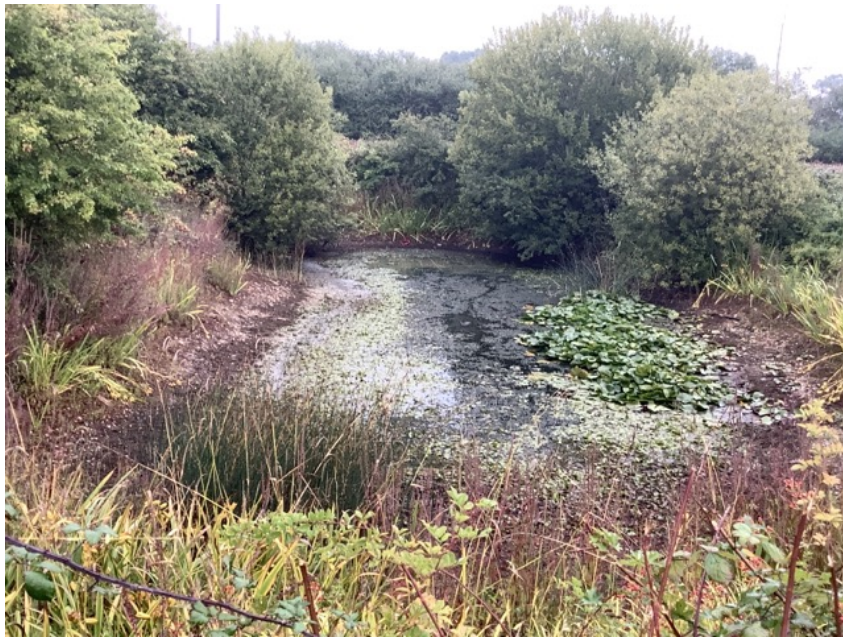
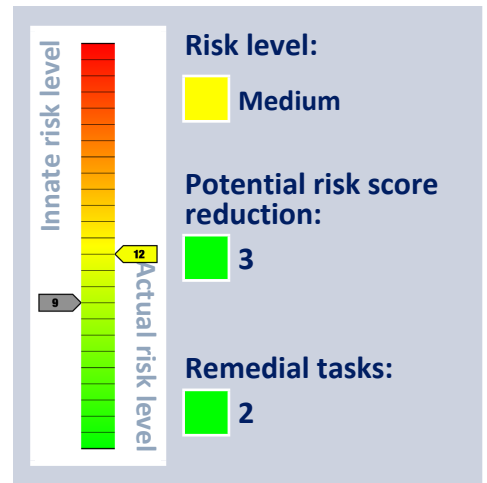
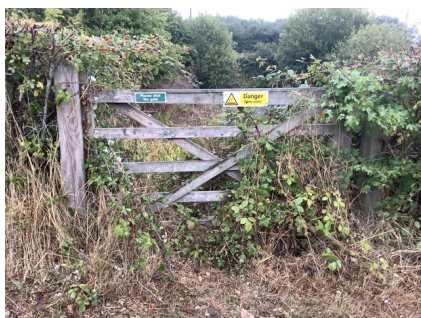
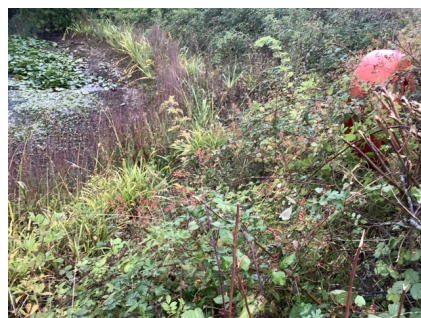
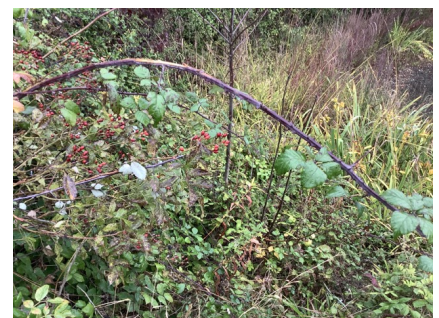
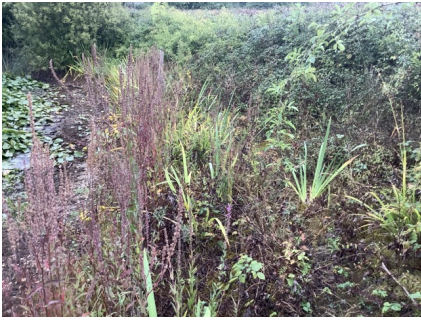
Pond

Surface has unintended weeds.

The vegetation around the area is progressively getting worse each year. Brambles surround the pond embankment could snag and cut a person (as per photo of inspector's scratched legs) while walking around the edges who could fall in to the water. Clear away brambles and ground weeds.

Medium

Read the notes for further action., Remove.
