Safety Inspection Report

Pond Inspection

Badingham Parish Council

23 September 2022

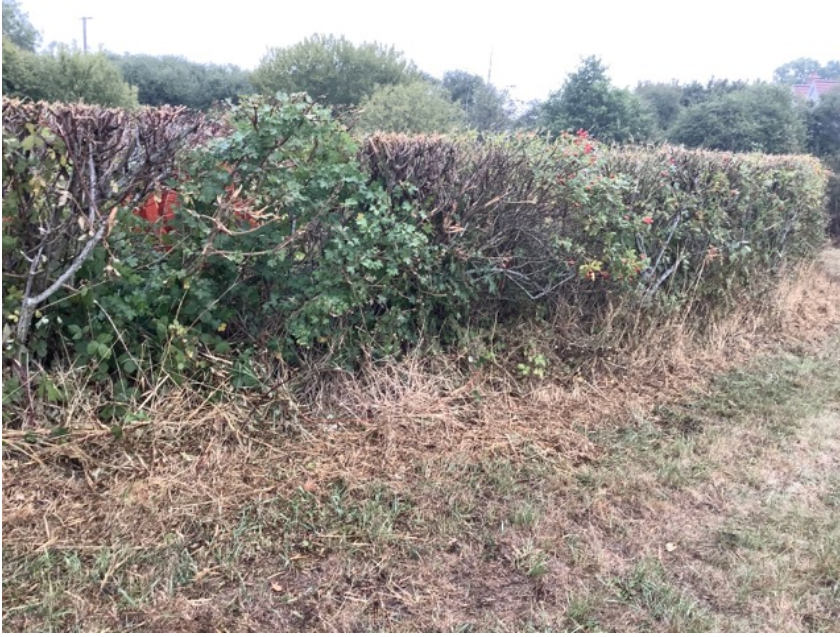
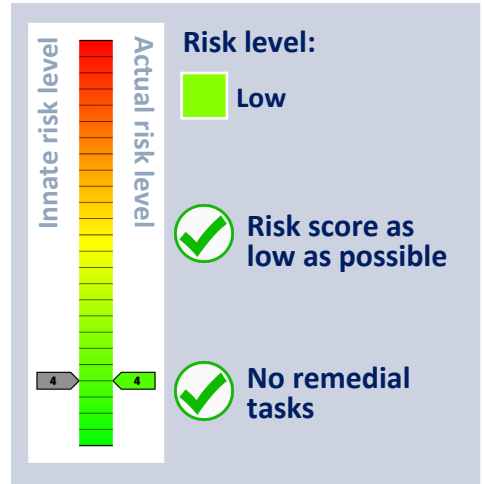
Hedging

Gate is climbable, and the access is made difficult without being cut / scratched due to the thorn bushes around the latch.

If there was an accident in the pond or pond area emergency access would be impeded.

Trim back hedge and vegetation around the gate and further into the area.
